# Guam Waterworks Authority (VP0989)

## CWA Collection System

Tumon, Guam

NEIC Field Investigation Photographs  
April 24 through May 4

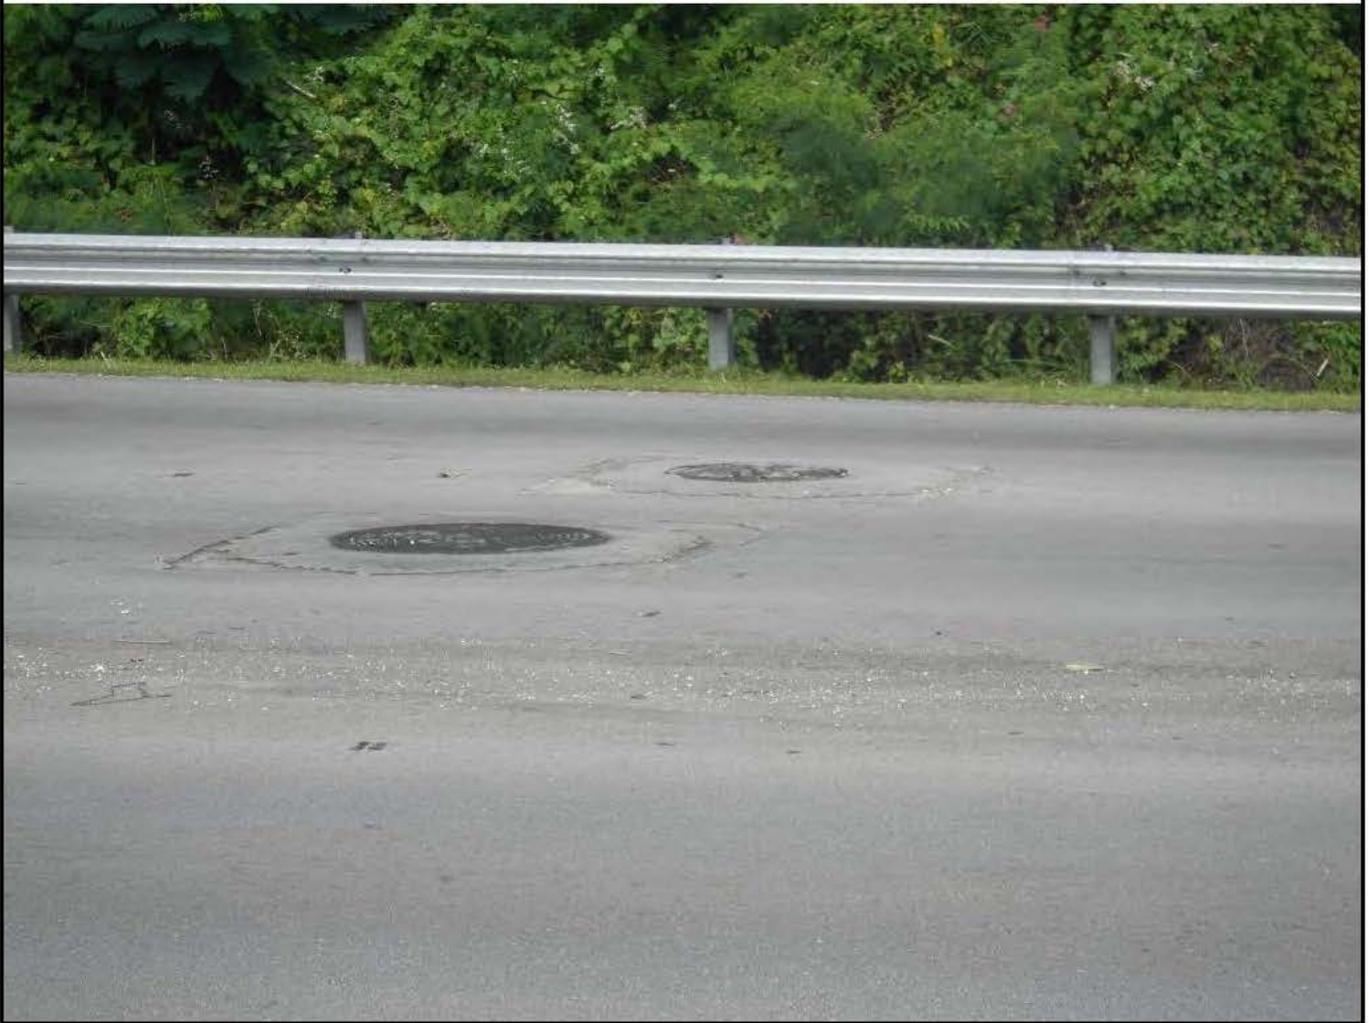
File Name: RIMG0097.JPG

Title	Guam Waterworks Authority (VP0989)
Subject	CWA Collection System
[REDACTED]	[REDACTED]
[REDACTED]	[REDACTED]
Date Time Stamp	5/1/2012 9:24:34 AM
Photographer	D. Vanlerberghe
Description	Manholes downstream of New Chaot pump station in Route 4 where frequent overflows occur.

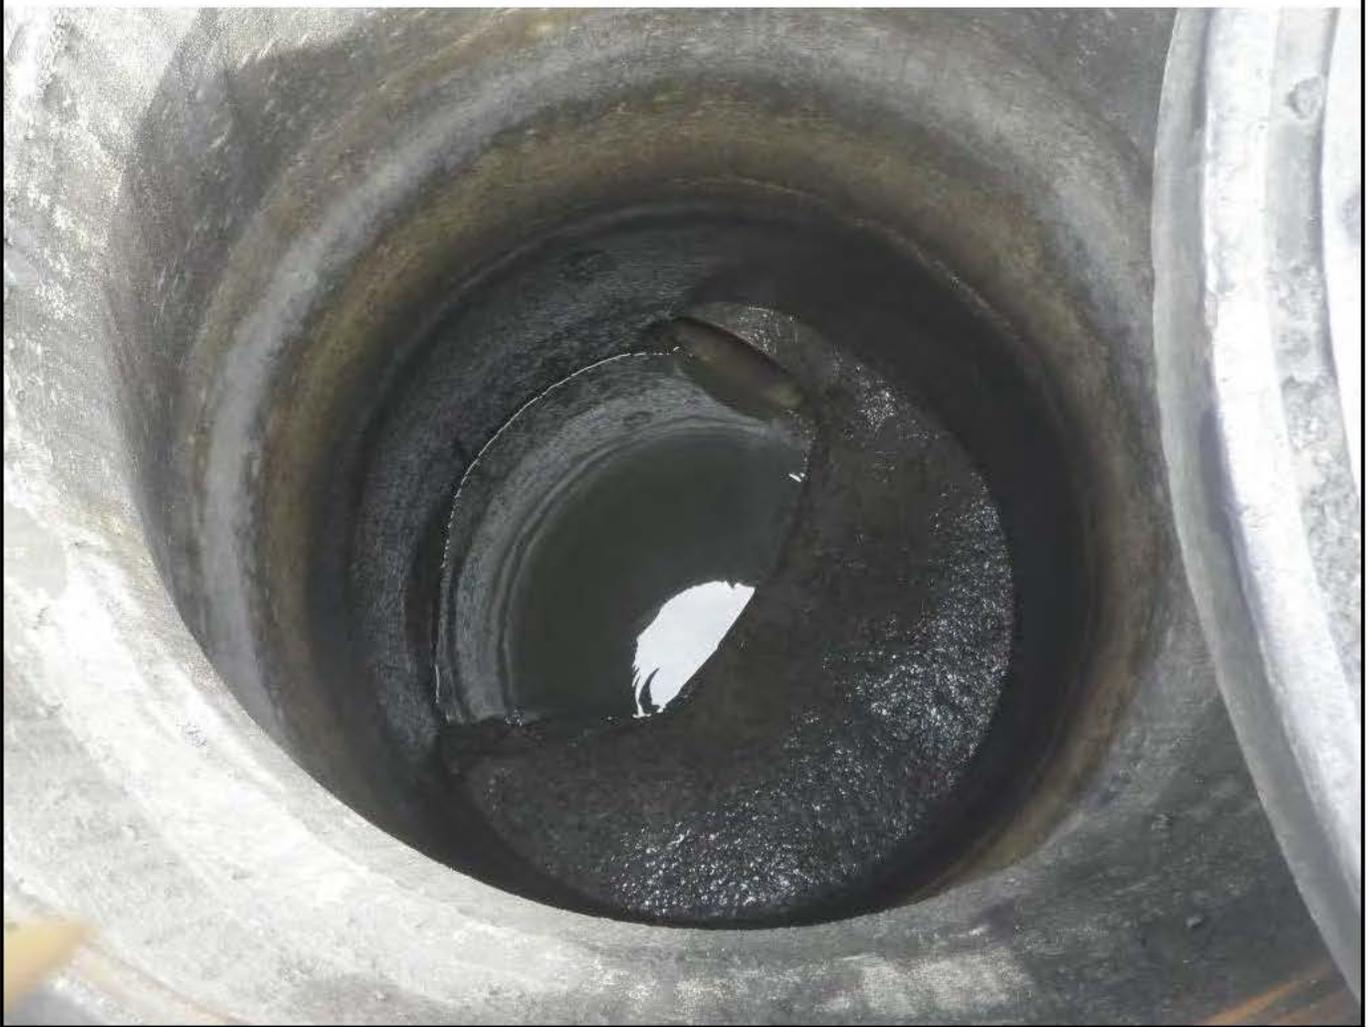
File Name: RIMG0098.JPG

<b>Title</b>	Guam Waterworks Authority (VP0989)
<b>Subject</b>	CWA Collection System
<b>Date Time Stamp</b>	5/1/2012 9:33:59 AM
<b>Photographer</b>	D. Vanlerberghe
<b>Description</b>	View inside manhole 940, in Route 4 downstream of the New Chaot pump station, where frequent overflows occur.

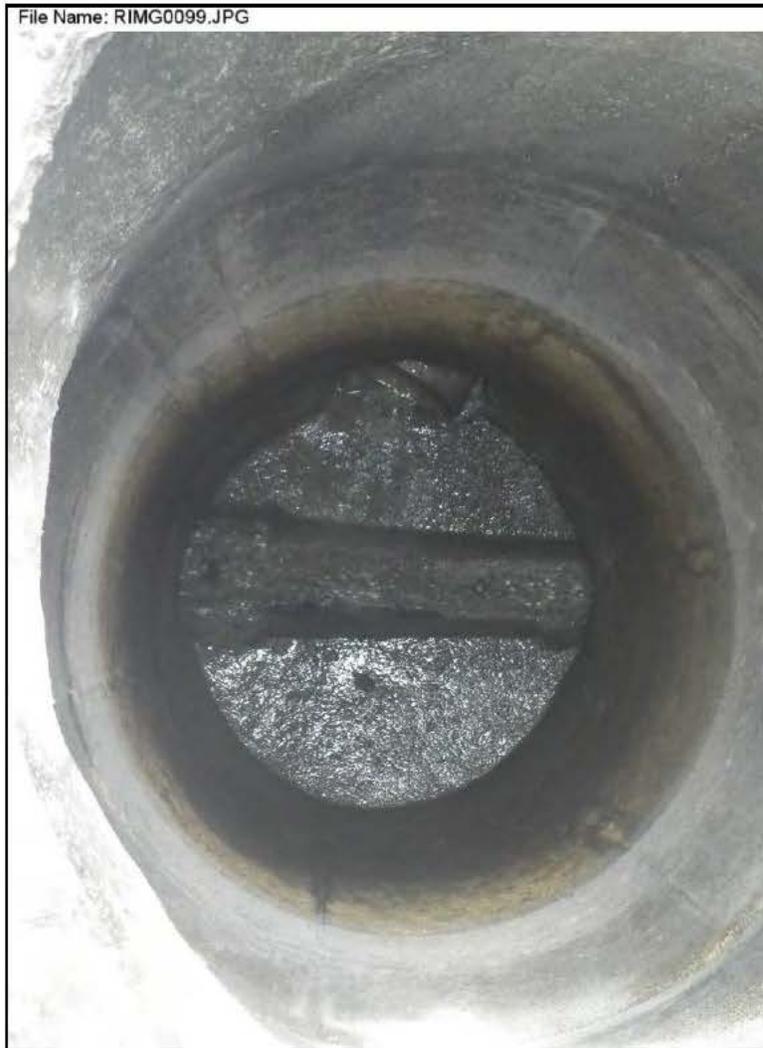
Attributes	
Title	
Subject	
Date Time Stamp	5/1/2012 9:38:33 AM
Photographer	D. Vanlerberghe
Description	View inside manhole 7635, in Route 4 downstream of the New Chaot pump station, where frequent overflows occur.

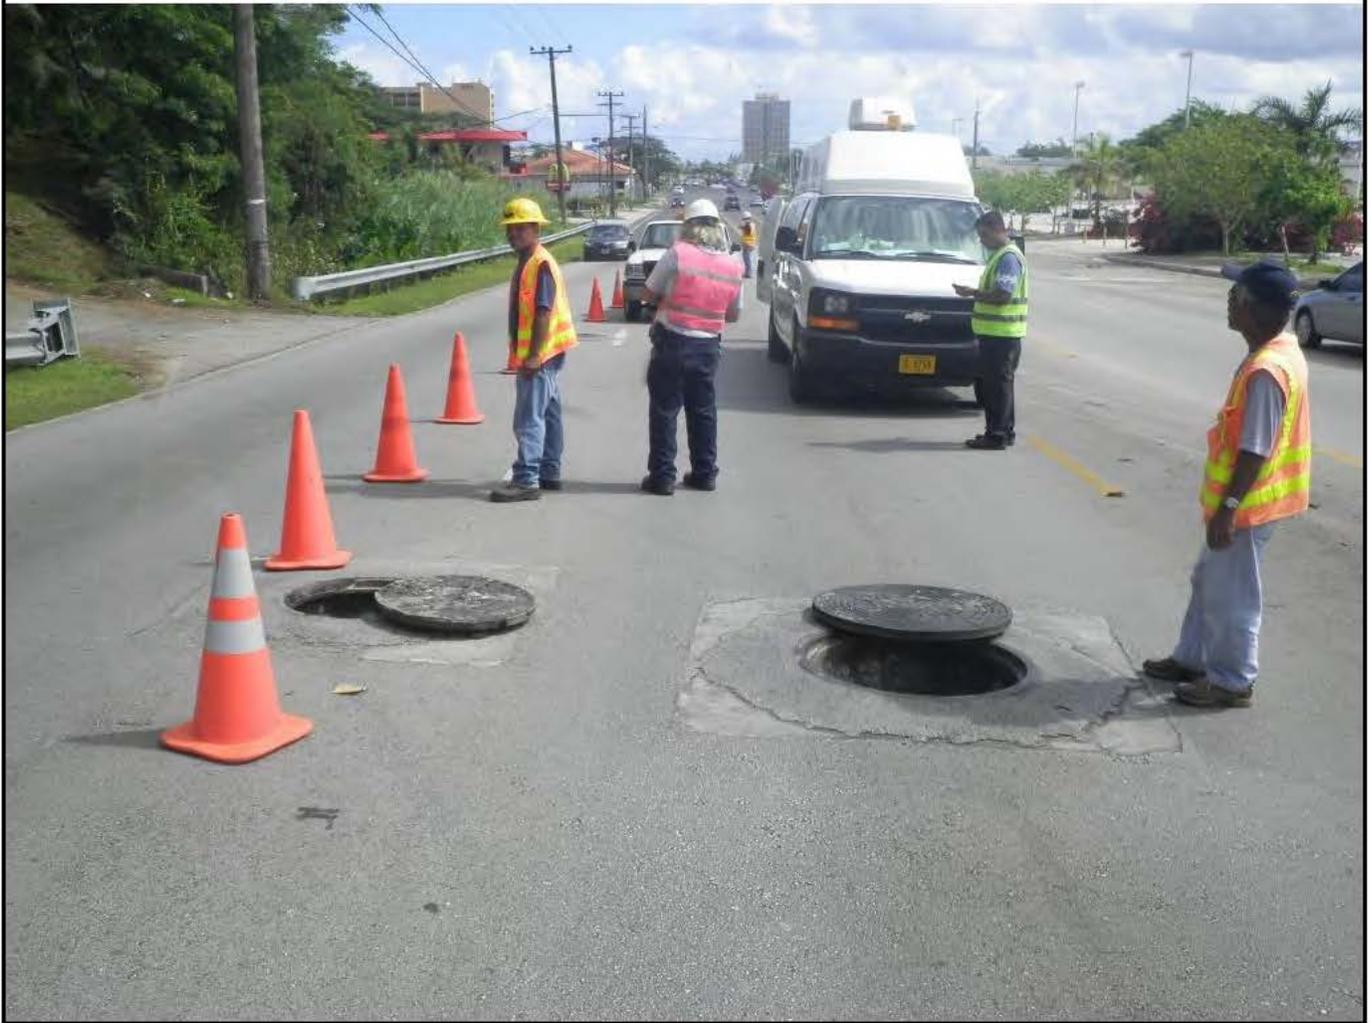
File Name: RIMG0100.JPG

Title	Guam Waterworks Authority (VP0989)
Subject	CWA Collection System
Date Time Stamp	5/1/2012 9:40:30 AM
Photographer	D. Vanlerberghe
Description	Manhole 7635 (left) and manhole 940 (right), in Route 4 downstream of the New Chaot pump station, where frequent overflows occur.

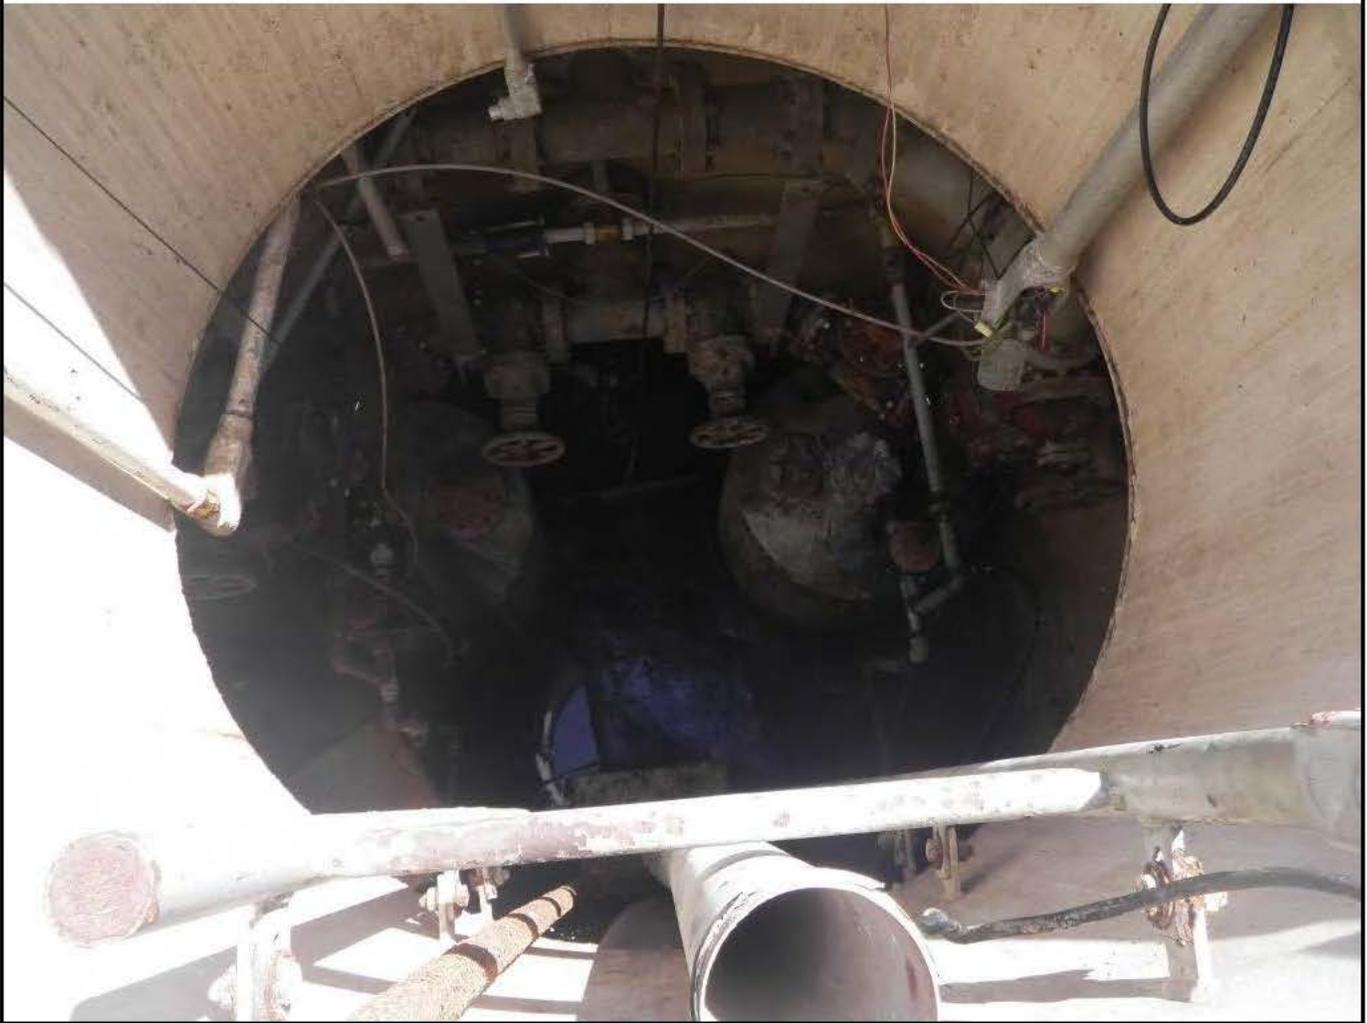
File Name: RIMG0101.JPG

Title	Guam Waterworks Authority (VP0989)
Subject	CWA Collection System
[REDACTED]	[REDACTED]
[REDACTED]	[REDACTED]
Date Time Stamp	5/1/2012 10:13:23 AM
Photographer	D. Vanlerberghe
Description	Namo pump station ejectors in pump station pit

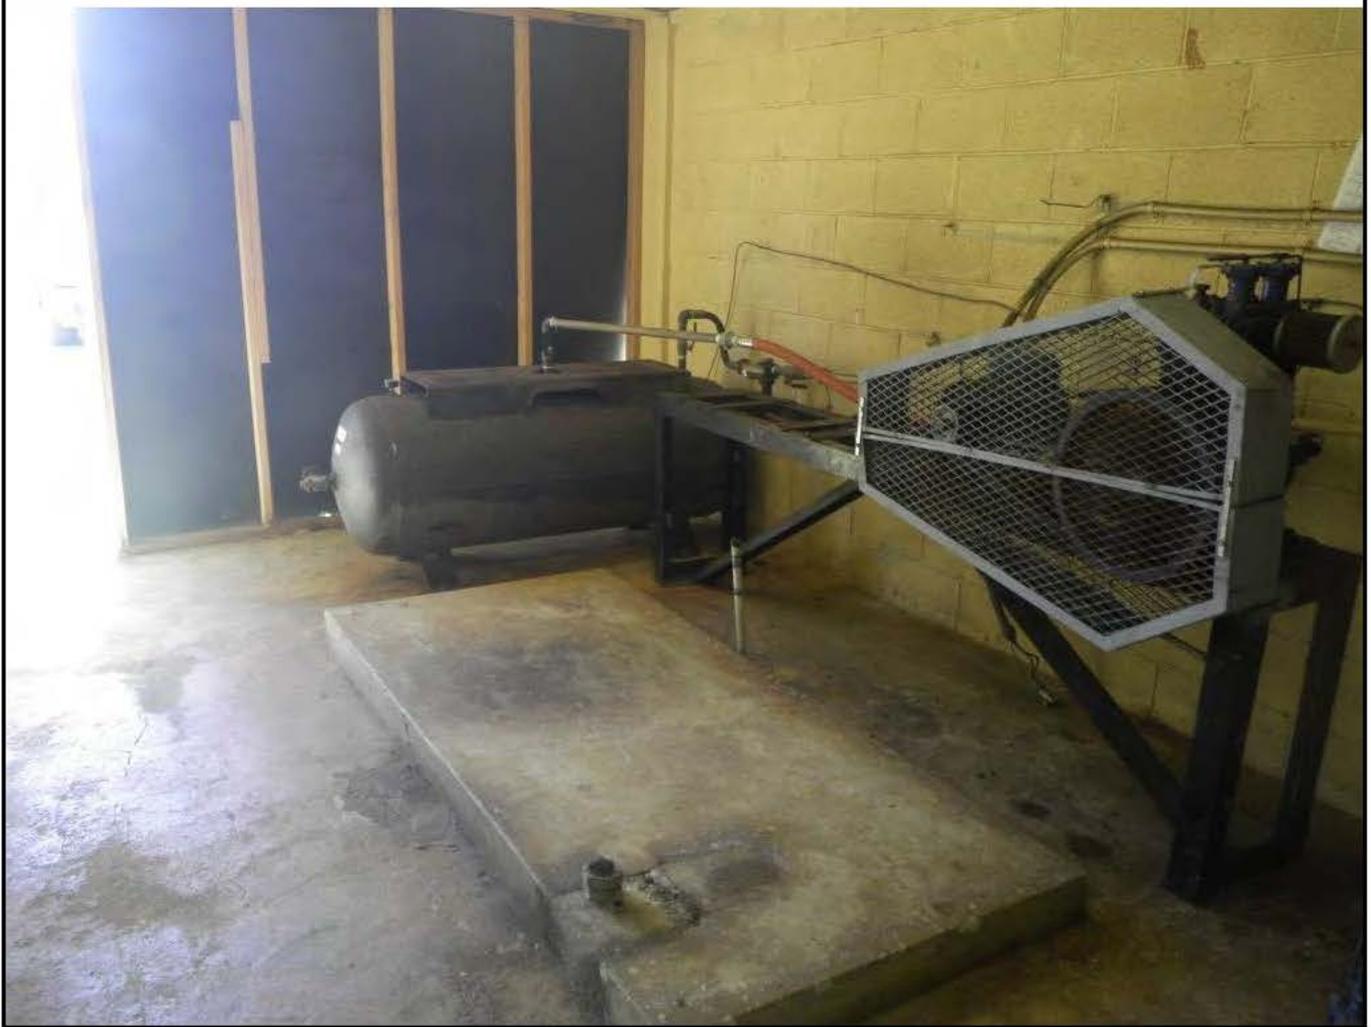
File Name: RIMG0102.JPG

<b>Title</b>	Guam Waterworks Authority (VP0989)
<b>Subject</b>	CWA Collection System
<b>Date Time Stamp</b>	5/1/2012 10:16:50 AM
<b>Photographer</b>	D. Vanlerberghe
<b>Description</b>	Namo pump station air compressor, motor, and control room.

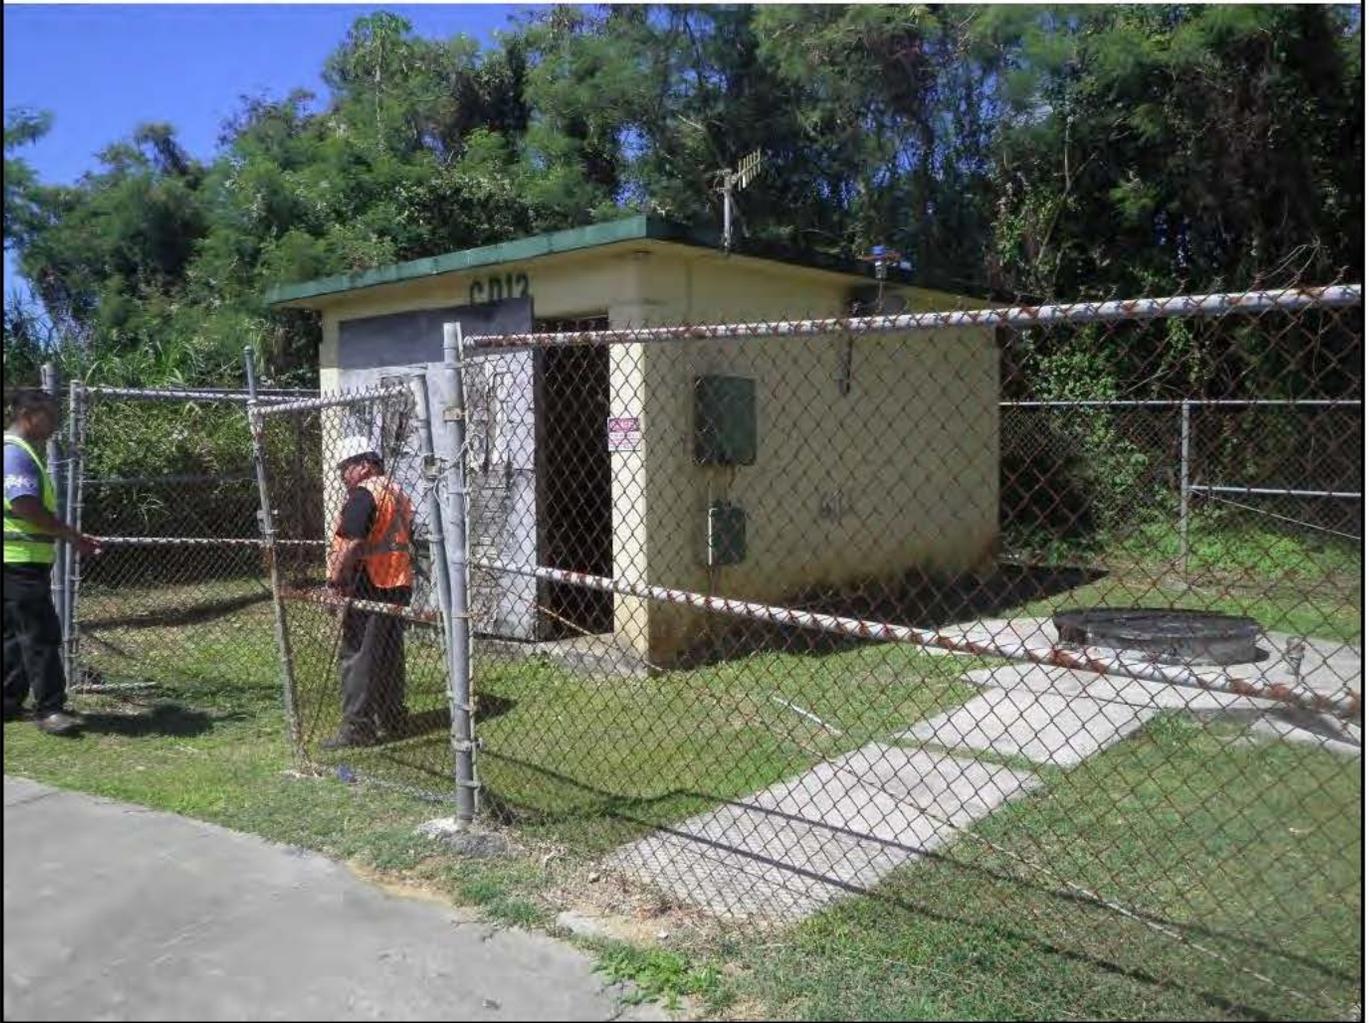
File Name: RIMG0103.JPG

Title	Guam Waterworks Authority (VP0989)
Subject	CWA Collection System
Date Time Stamp	5/1/2012 10:18:58 AM
Photographer	D. Vanlerberghe
Description	Namo pump station building.

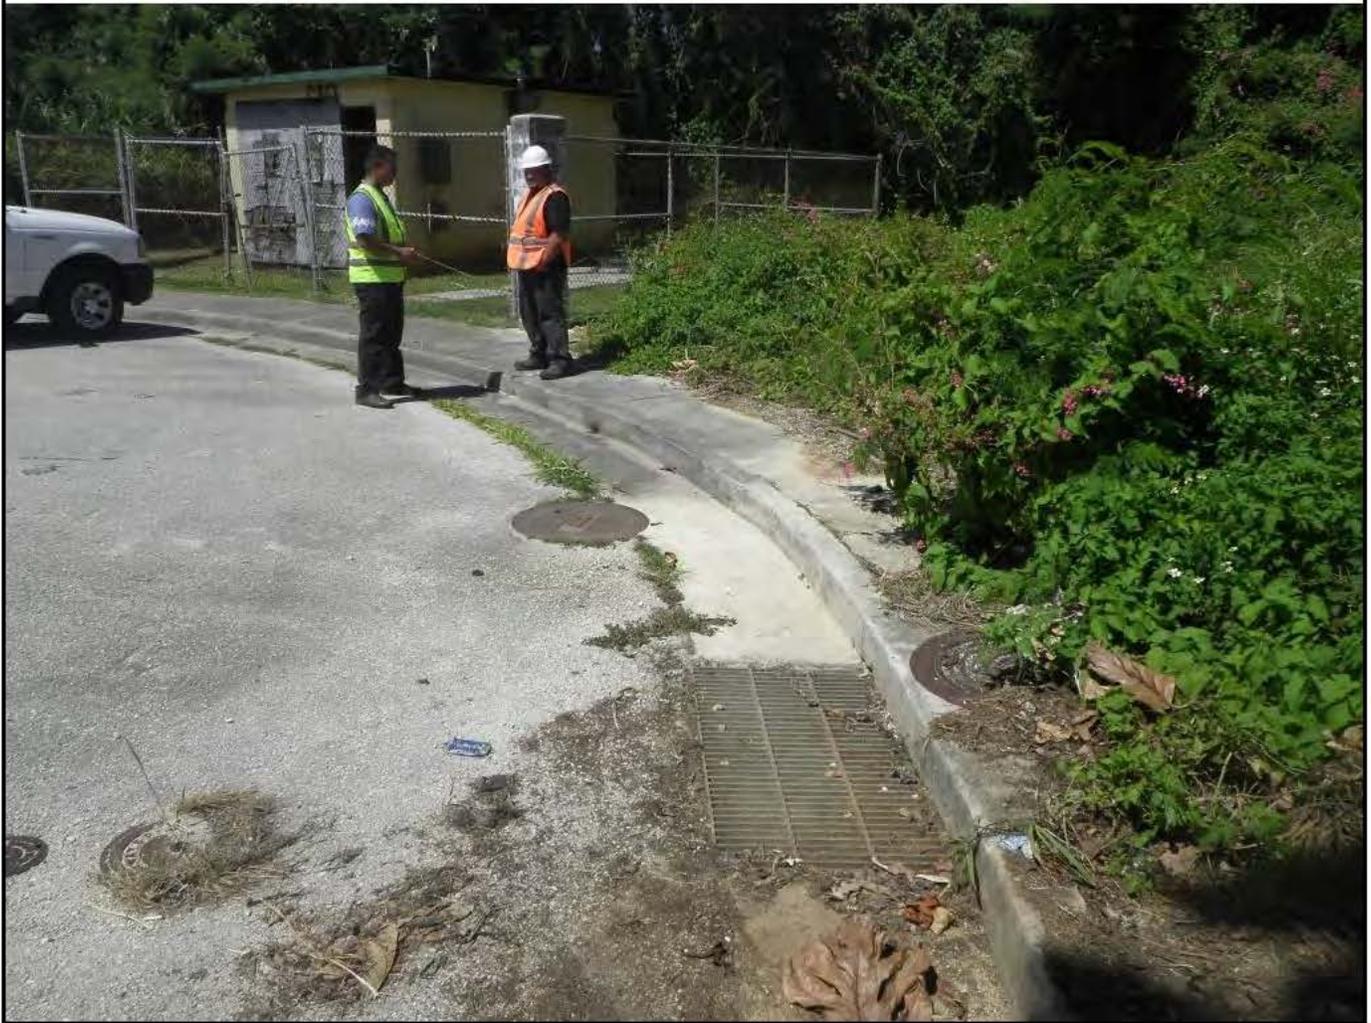
File Name: RIMG0104.JPG

Title	Guam Waterworks Authority (VP0989)
Subject	CWA Collection System
Date Time Stamp	5/1/2012 10:21:03 AM
Photographer	D. Vanlerberghe
Description	Namo pump station, with manhole subject to overflows near storm drain (foreground).

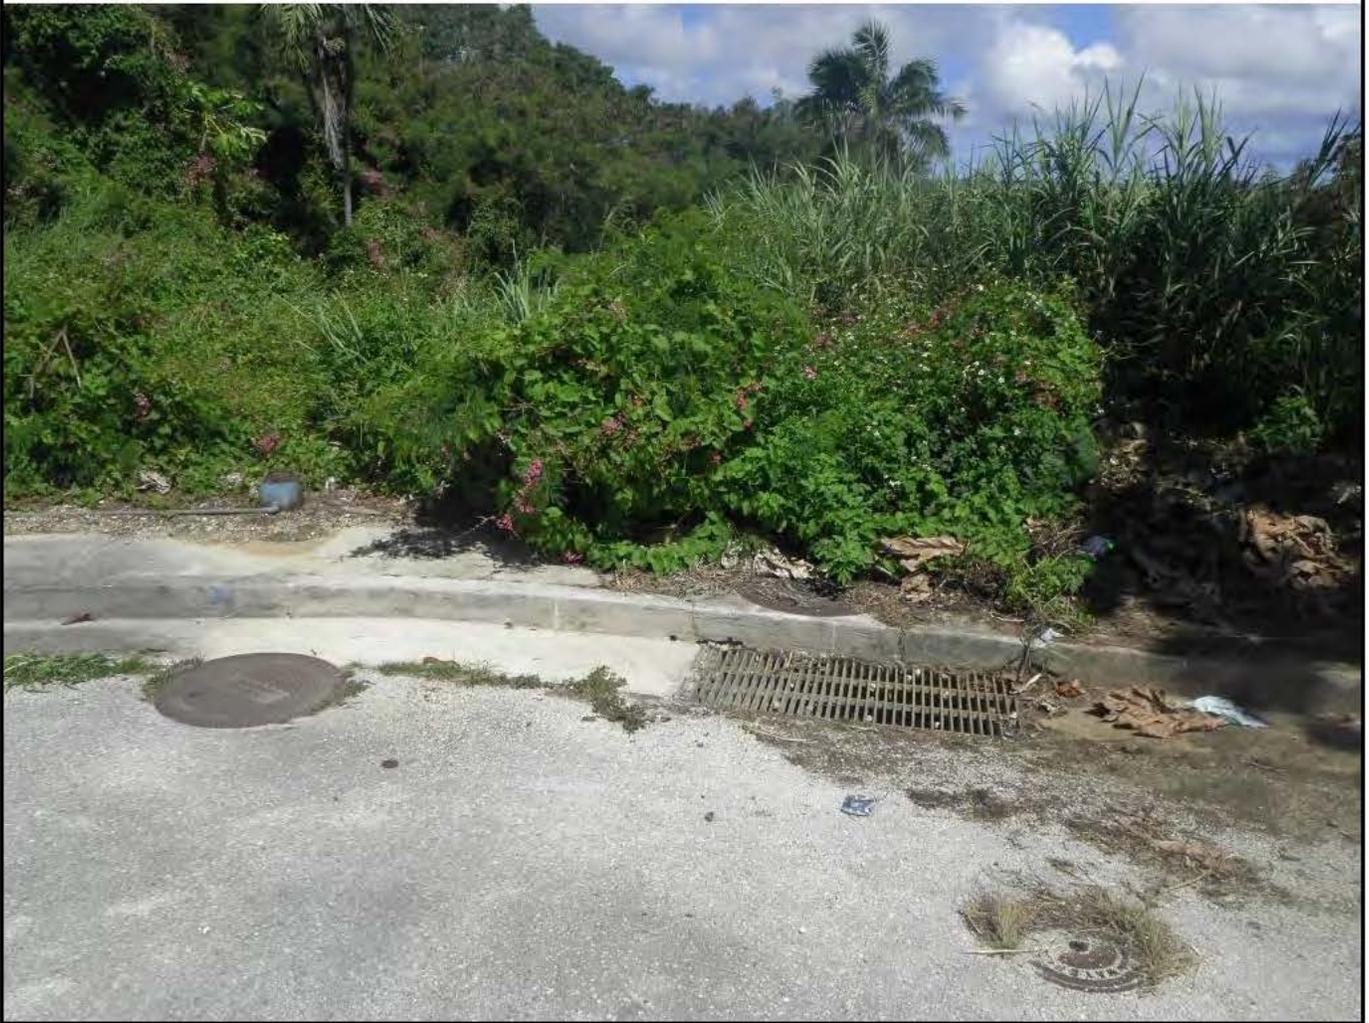
File Name: RIMG0105.JPG

Title	Guam Waterworks Authority (VP0989)
Subject	CWA Collection System
Date Time Stamp	5/1/2012 10:21:20 AM
Photographer	D. Vanlerberghe
Description	Namo pump station, manhole subject to overflows (left) near storm drain (right).

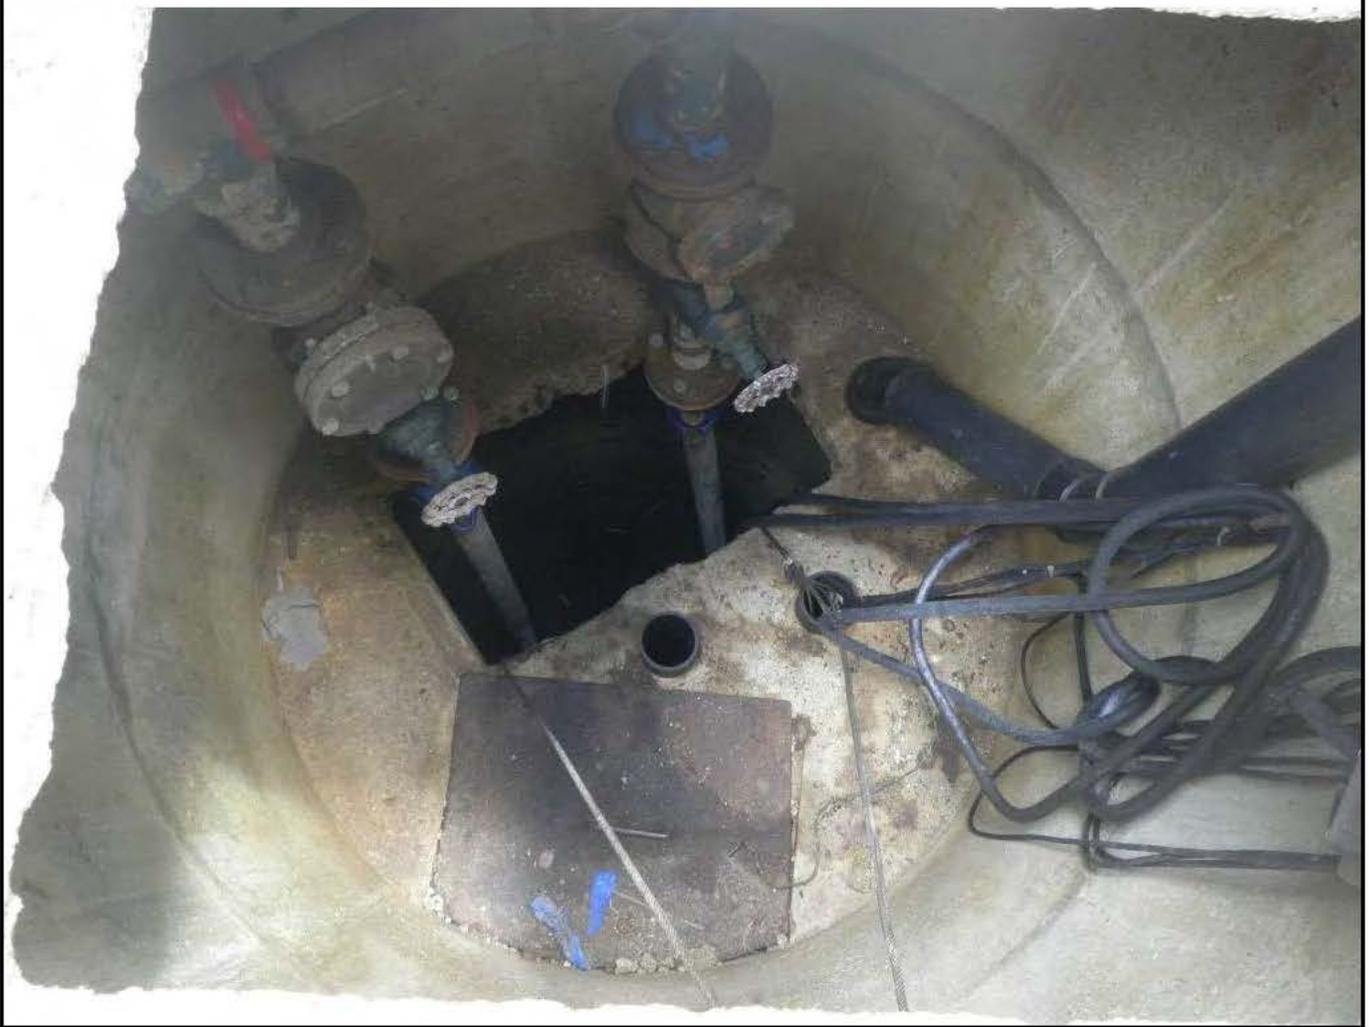
File Name: RIMG0106.JPG

Title	Guam Waterworks Authority (VP0989)
Subject	CWA Collection System
Date Time Stamp	5/1/2012 10:45:05 AM
Photographer	D. Vanlerberghe
Description	Casimero pump station wet well.

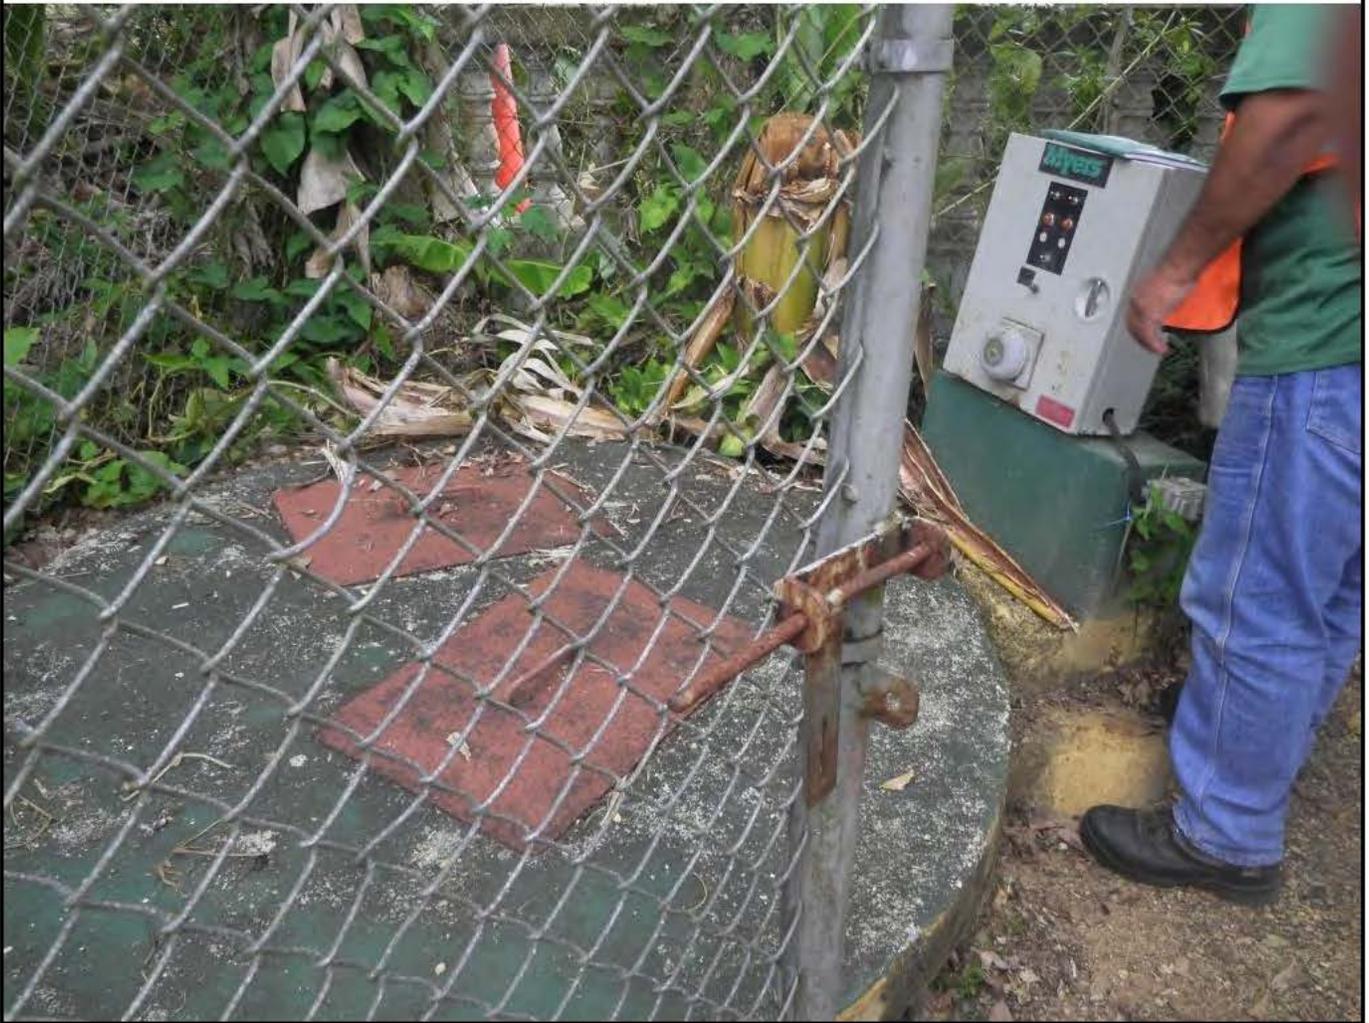
File Name: RIMG0107.JPG

Title	Guam Waterworks Authority (VP0989)
Subject	CWA Collection System
Date Time Stamp	5/1/2012 10:48:00 AM
Photographer	D. Vanlerberghe
Description	Casimero pump station controls.

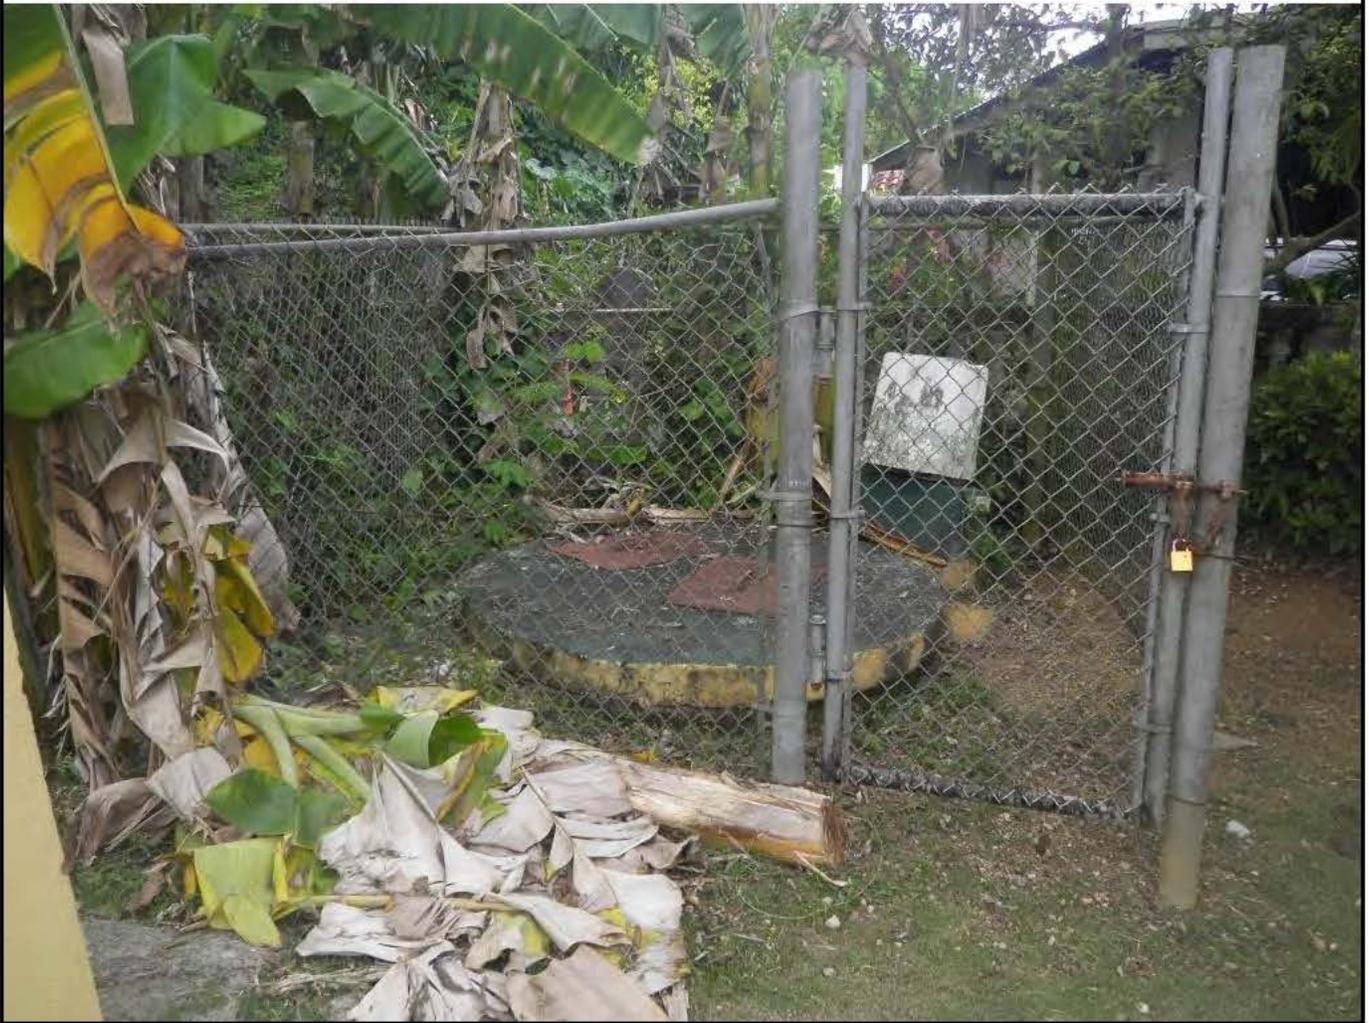
File Name: RIMG0108.JPG

<b>Title</b>	Guam Waterworks Authority (VP0989)
<b>Subject</b>	CWA Collection System
<b>Date Time Stamp</b>	5/1/2012 10:48:32 AM
<b>Photographer</b>	D. Vanlerberghe
<b>Description</b>	Casimero pump station area, with no building and no backup power.

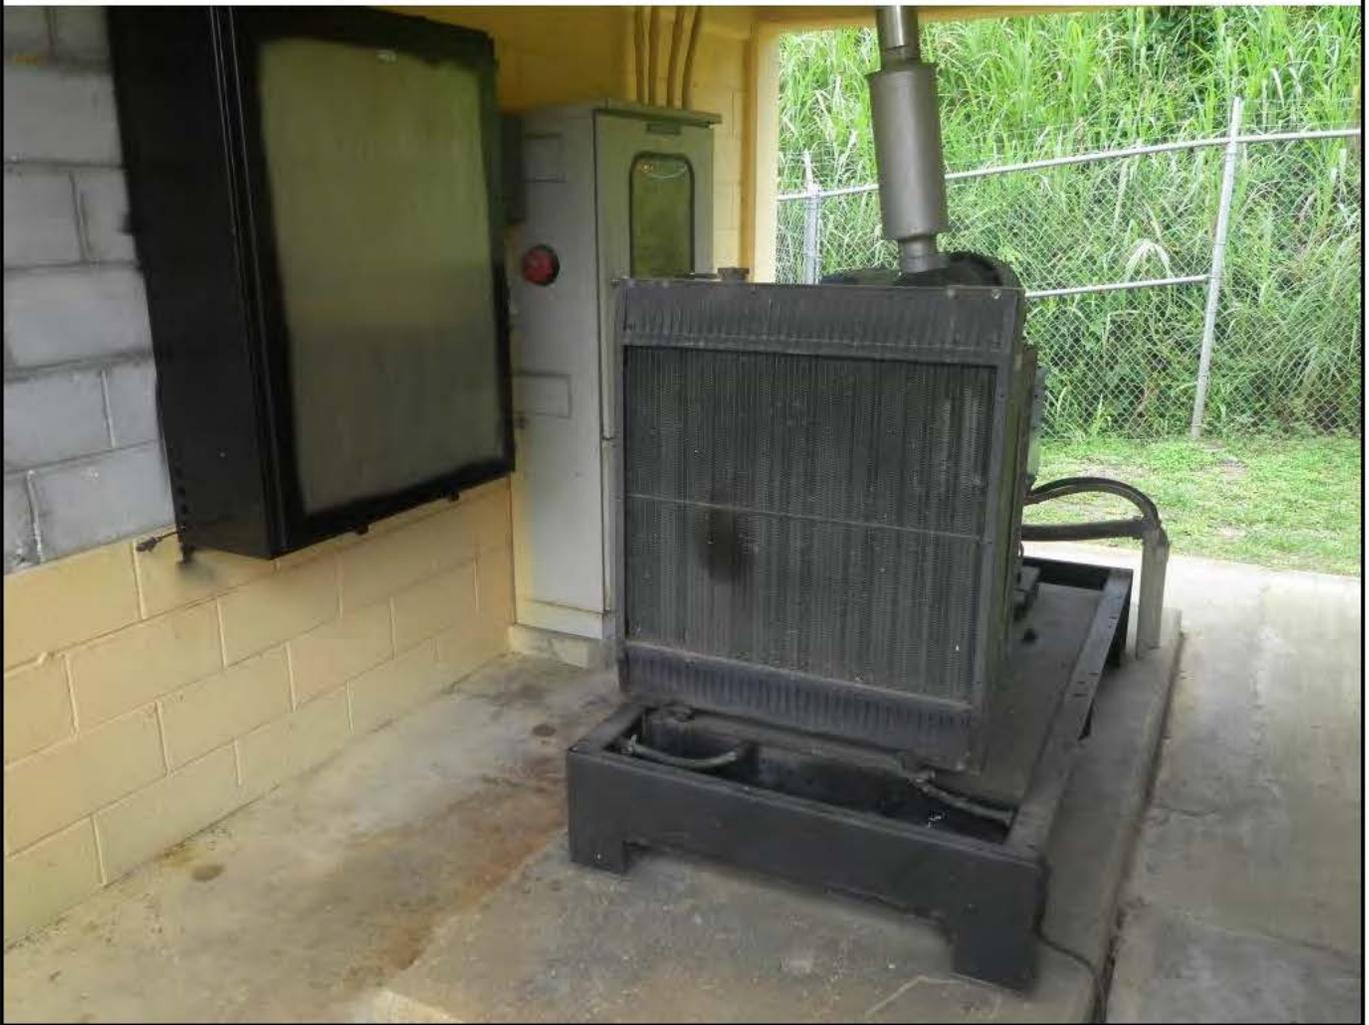
File Name: RIMG0109.JPG

Title	Guam Waterworks Authority (VP0989)
Subject	CWA Collection System
Date Time Stamp	5/1/2012 10:59:05 AM
Photographer	D. Vanlerberghe
Description	Mong Mong pump station standby generator and pump controls.

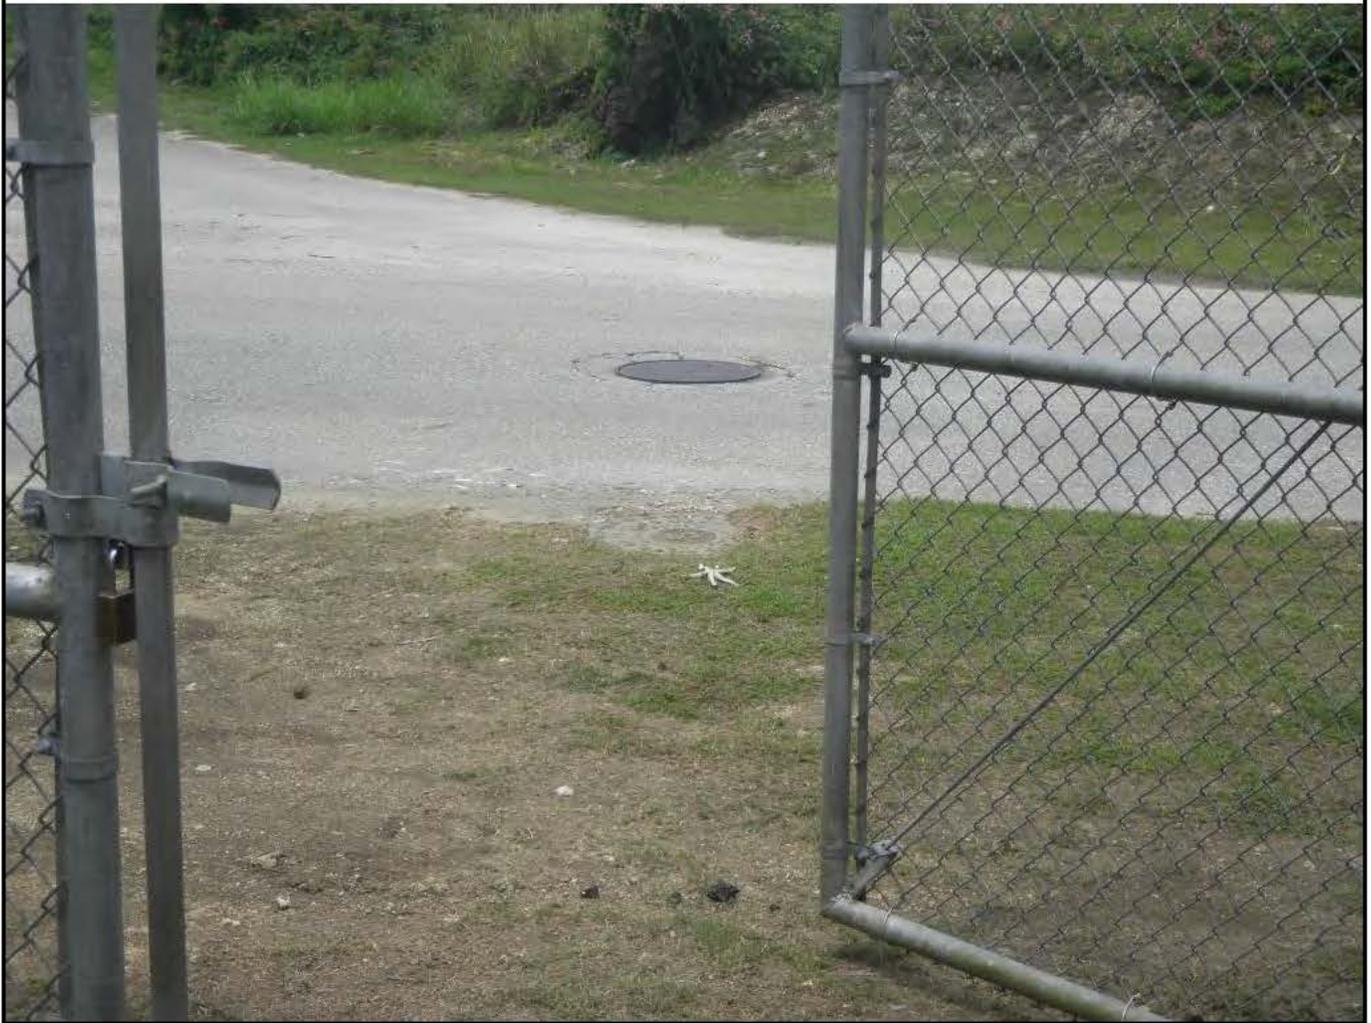
File Name: RIMG0111.JPG

<b>Title</b>	Guam Waterworks Authority (VP0989)
<b>Subject</b>	CWA Collection System
<b>Date Time Stamp</b>	5/1/2012 11:00:56 AM
<b>Photographer</b>	D. Vanlerberghe
<b>Description</b>	Mong Mong pump station wet well manhole (foreground).

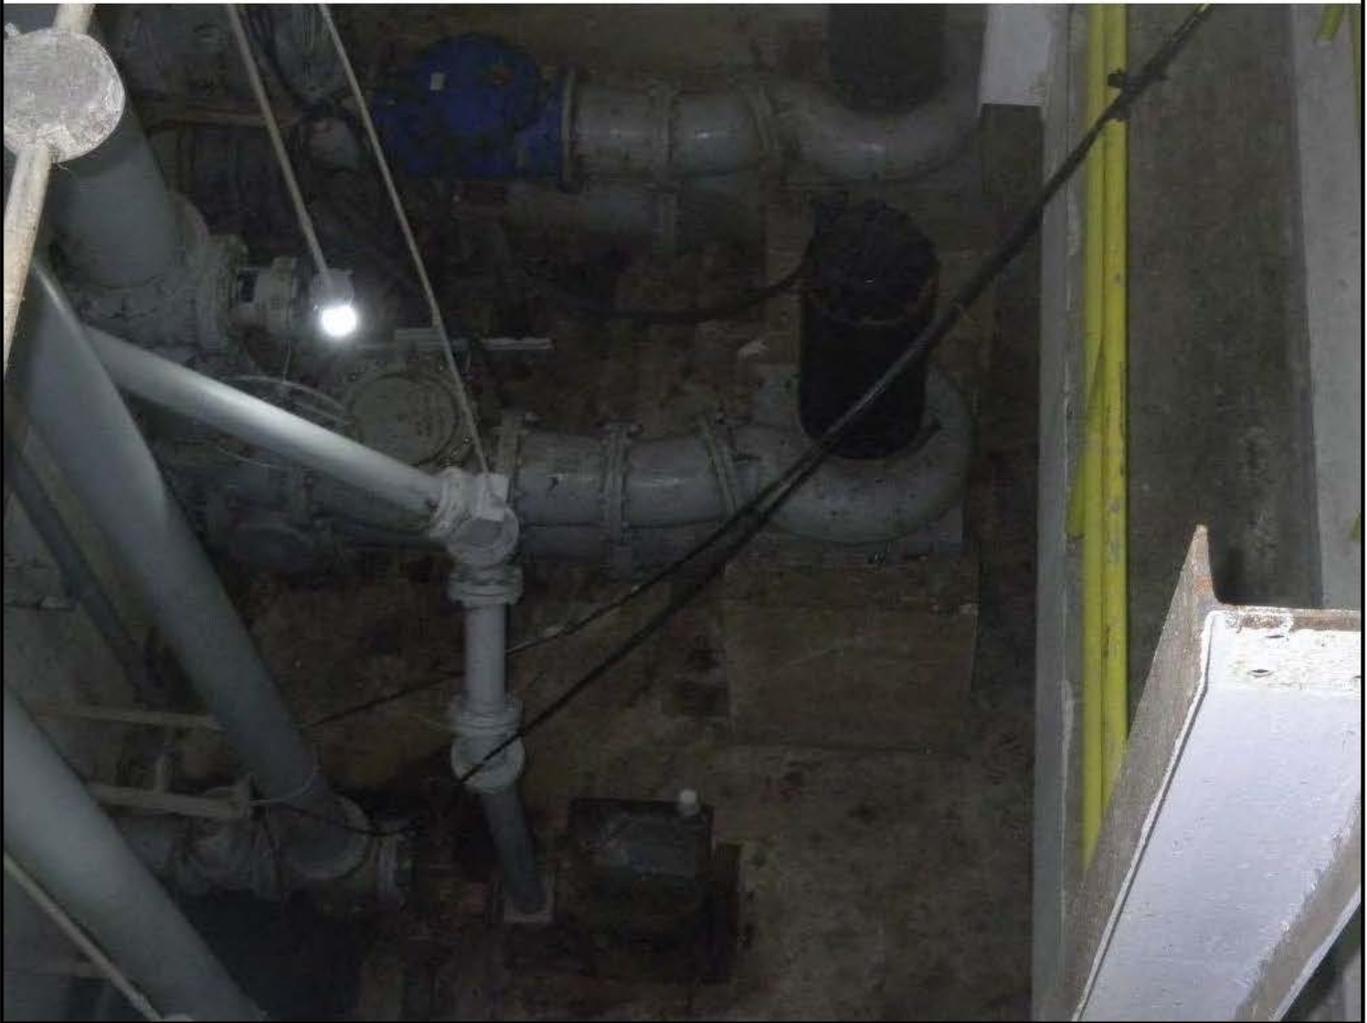
File Name: RIMG0112.JPG

<b>Title</b>	Guam Waterworks Authority (VP0989)
<b>Subject</b>	CWA Collection System
<b>Date Time Stamp</b>	5/1/2012 11:21:27 AM
<b>Photographer</b>	D. Vanlerberghe
<b>Description</b>	Agana Main pump station pumps.

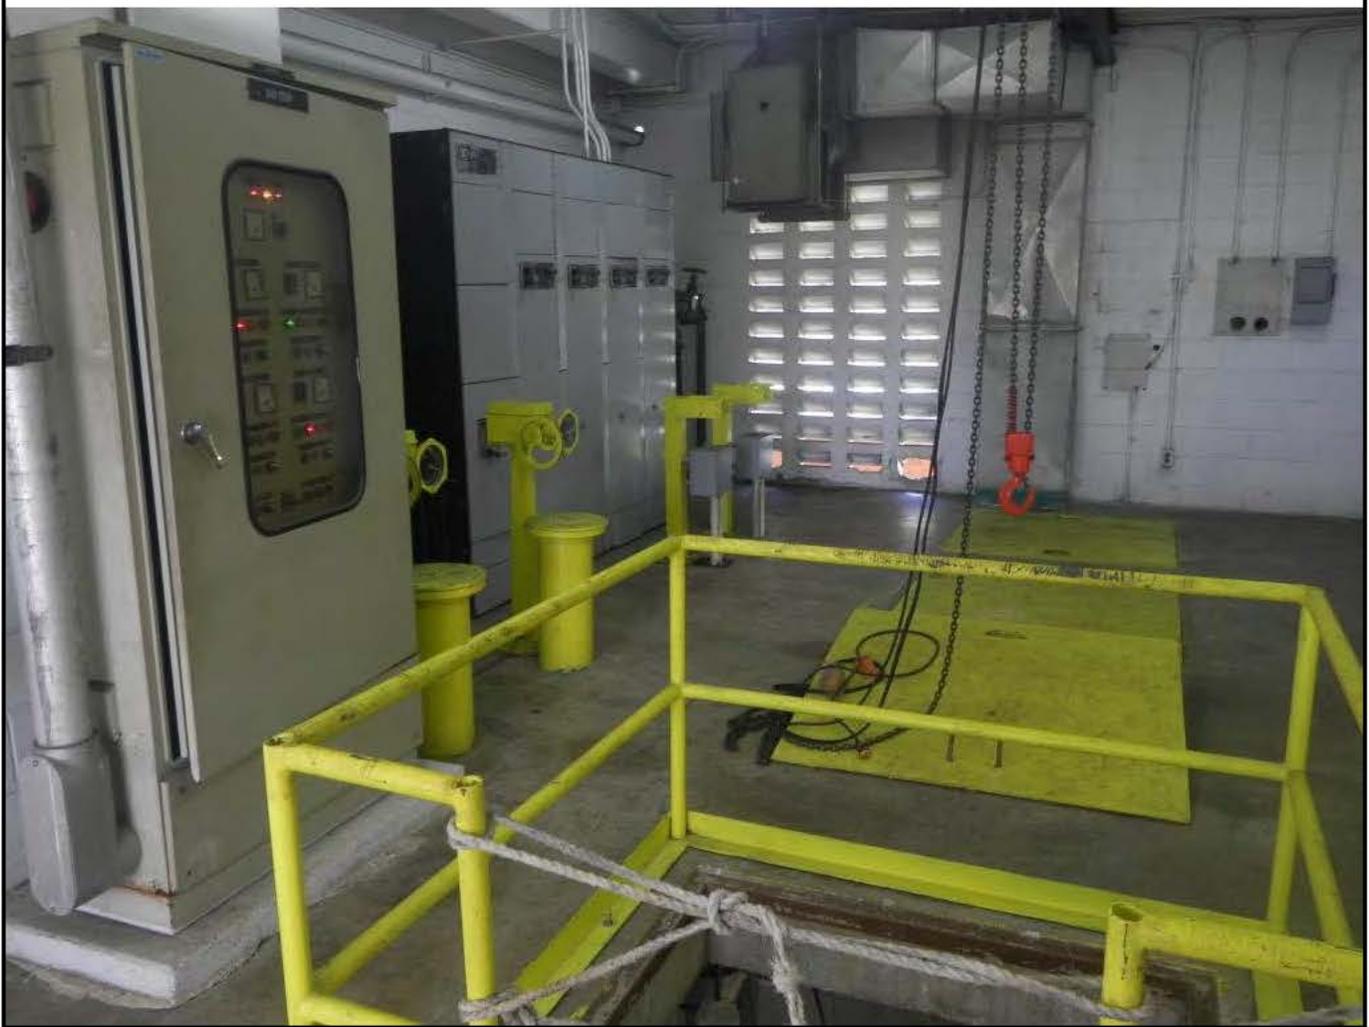
File Name: RIMG0113.JPG

Title	Guam Waterworks Authority (VP0989)
Subject	CWA Collection System
[REDACTED]	[REDACTED]
[REDACTED]	[REDACTED]
Date Time Stamp	5/1/2012 11:21:44 AM
Photographer	D. Vanlerberghe
Description	Agana Main pump station control room.
